Graphite Fiber Reinforced Thermoplastic Resins

United Technologies Research Center
East Hartford, Ct. 06108

National Aeronautics and Space Administration
NASA Lewis Research Center
Contract NAS3-20077

1. Report No. NASA CR-135196		2. Government Accession No.		3. Recipient's Catalog No.	
4. Title and Subtitle GRAPHITE FIBER REINFORCED THERMOPLASTIC RESINS				5. Report Date April 18, 1977

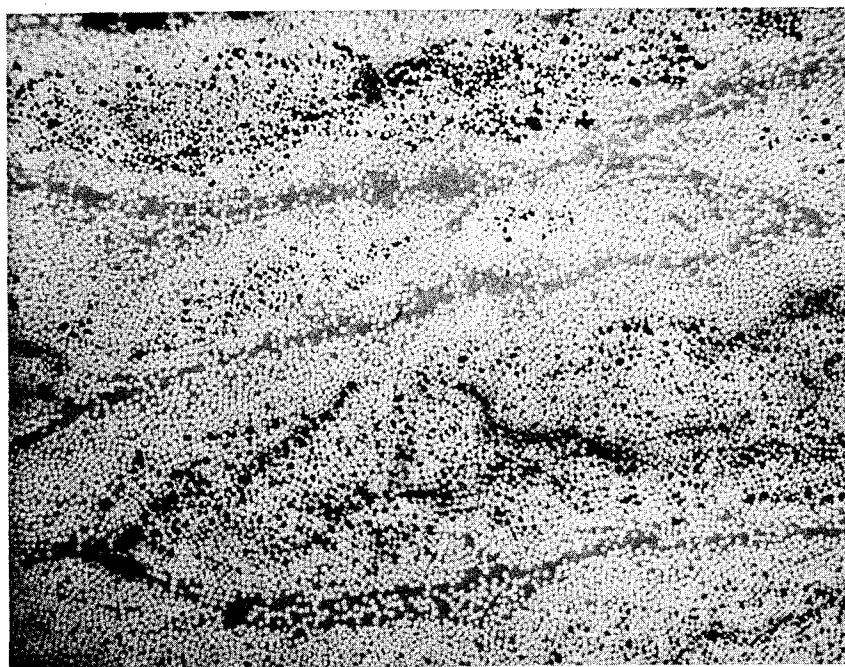
HMS/P-1700 POLYSULFONE COMPOSITE MADE UNDER BASELINE CONDITIONS

A sample from each specimen was polished and examined microscopically. Based on that examination, selected specimens were submitted for flexural and short beam shear testing. The conditions utilized in Ref. 1 for Thornel 300/P-1700 polysulfone were similar to those of run number 2 except the pressure was 6.9 MPa. Figure 1 is a photomicrograph of the baseline specimen of

HMS/P-1700 polysulfone using the Ref. 1 conditions, and shows high degree of porosity. This porosity is substantially greater than observed with the T300 composites and may be due to a greater difficulty in the resin penetrating the larger HMS tow.

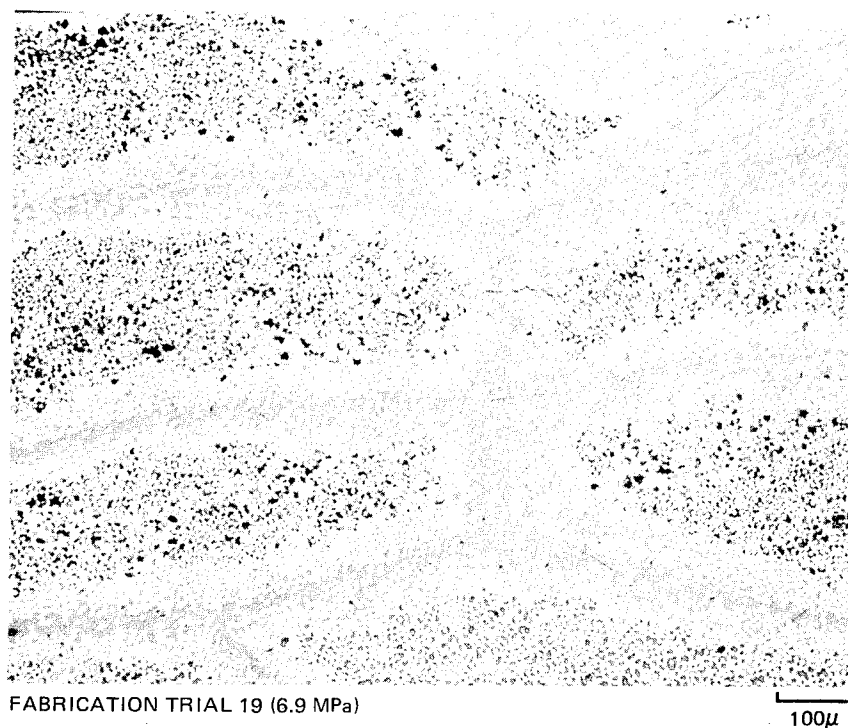
EFFECT OF CONSOLIDATION PRESSURE ON HMS/P-1700 POLYSULFONE

One path which was explored to reduce this porosity was to use a more dilute solution thereby lowering the viscosity and improving the chances of the resin fully penetrating the bundle. It was demonstrated that the 7.5% resin solutions did not provide sufficient resin in the composite, and at least an 8.7% solution was necessary. The effect of the lower concentration is shown in Fig. 2. It was also shown that the application of greater pressure, as in numbers 19 and 22 where the latter was hot pressed at a pressure five times higher than the former, did not improve the microstructure of the composite as illustrated in Fig. 3.
